壊れた原子炉の冷却と地下水の流入

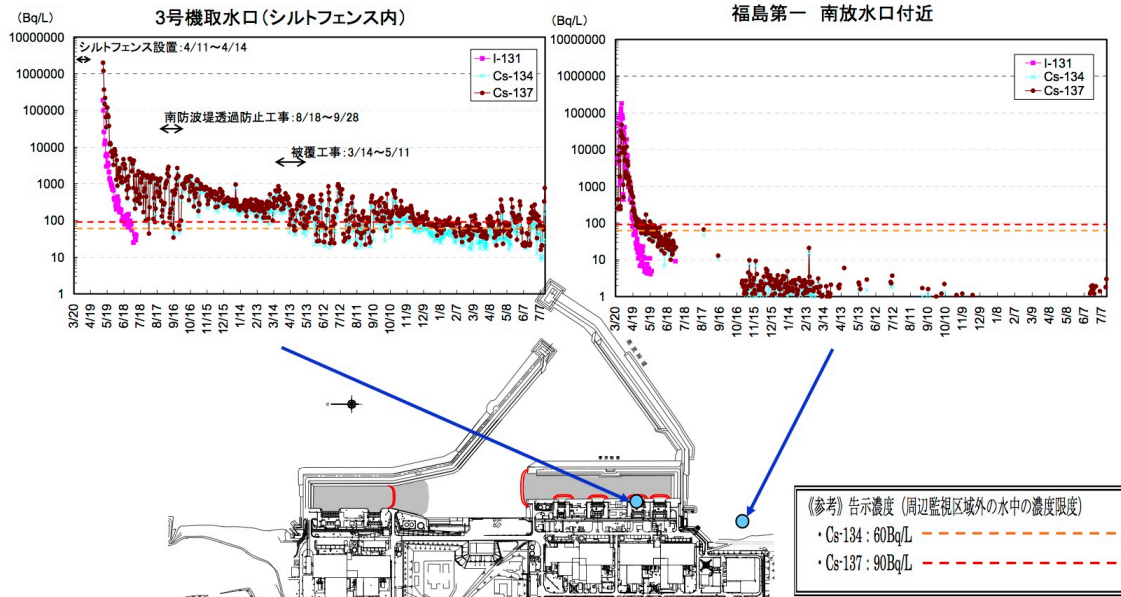
港湾の海水の分析結果

● 1～4号機の取水口で現在10～100Bq/LのCs137を検出

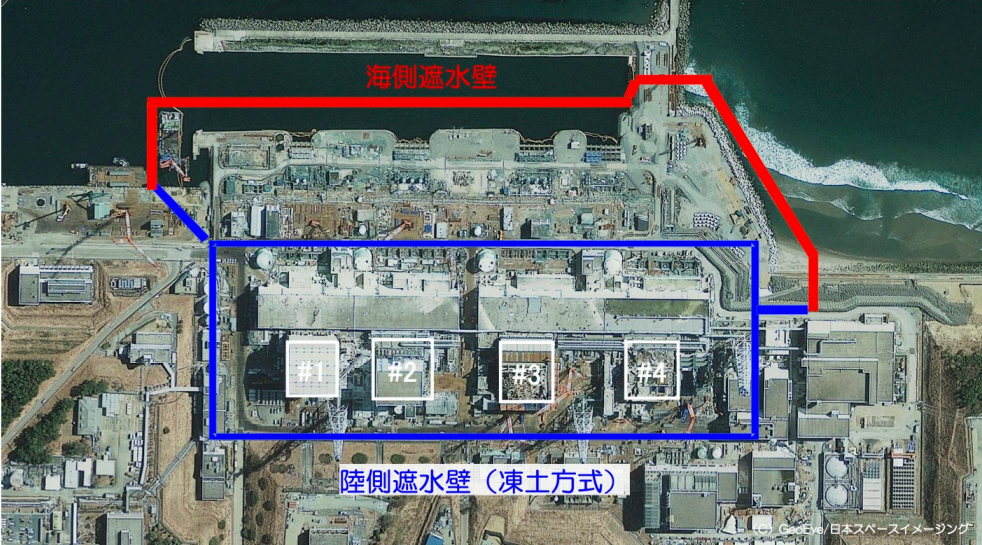
遮水壁による地下水の接近と流出防止対策

- 海洋流出の阻止 海側遮水壁の設置
- 汚染水増加抑制・港湾流出の防止 . . . 陸側遮水壁の設置
